## Lacey City Council Worksession Agenda

**B. McKinney Building Removal**

**Historic Preservation Consultant Services for Three Historic Properties, Lacey,  
Thurston County, Washington**

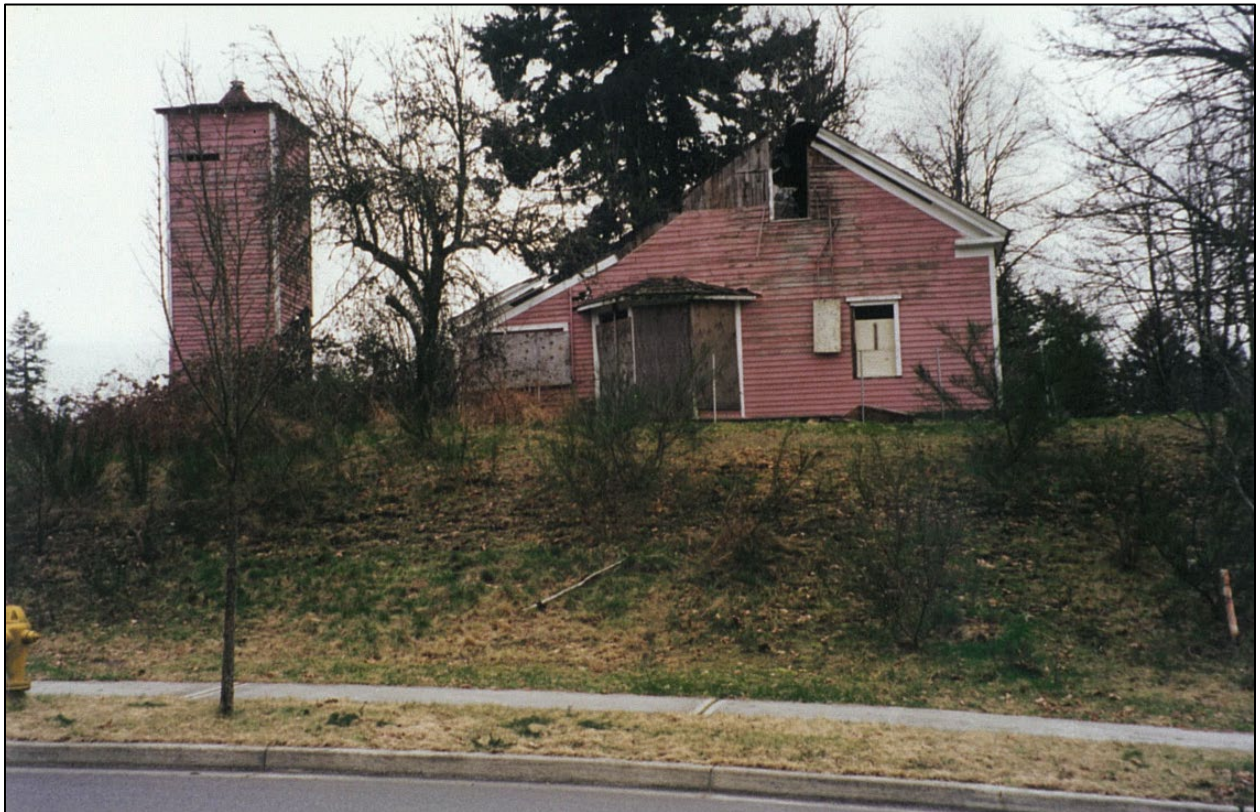
**Photo 1. View of the Jacob Smith House, west façade, with water tower, taken c. 1990s.**

Built in 1859, the house is a one-and-one-half-story Folk Victorian structure with Greek Revival design elements. According to historic photographs taken in 1890 and 1940, the house had undergone the addition of a full-width porch and an associated water tower. A detached garage was built circa 1950 and rebuilt c. 1996-1997, connecting the tower and main house via an open-air breezeway (Photos 1–3).

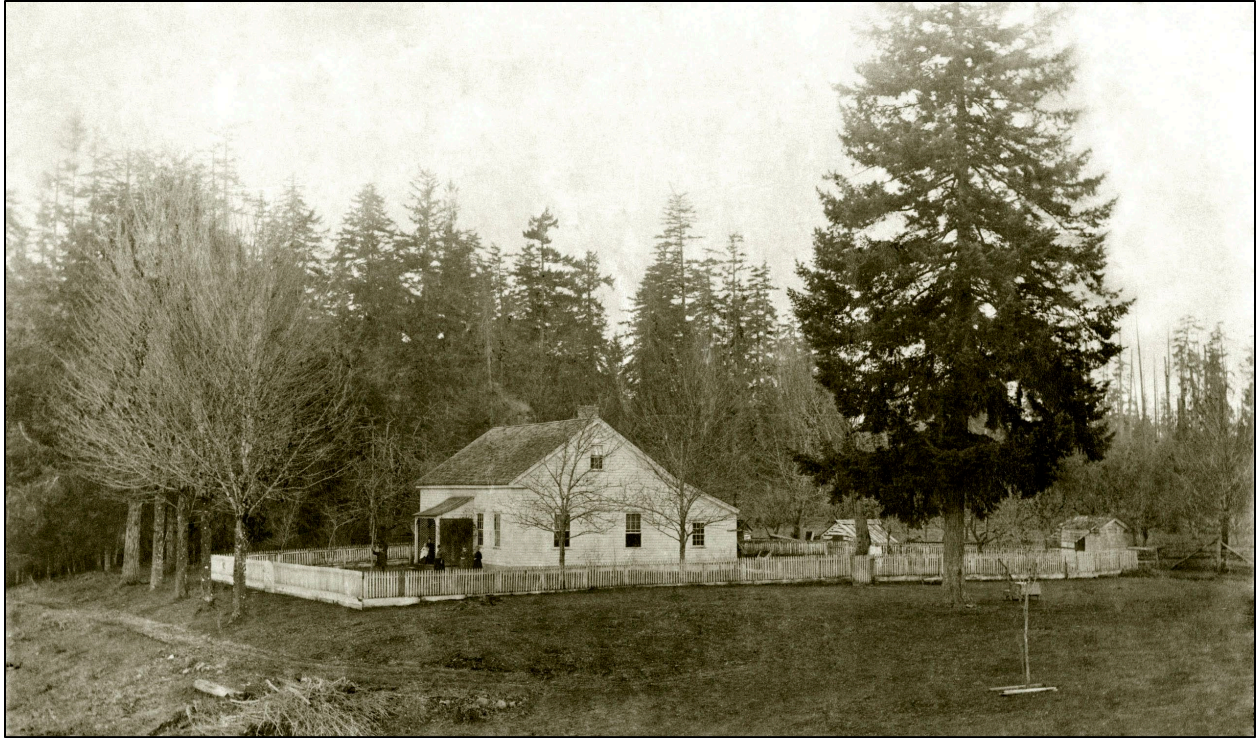
**Photo 4. An early image of the Jacob Smith House.**

Set on a southwest–northeast axis, the house is a one-and-one-half-story, side-gabled Victorian Folk construction with Greek Revival stylistic elements. The structure has a rectangular footprint and sits on a raised foundation, with horizontal wood lap siding painted in a light, neutral tone (Photo 4).

It is characterized by its symmetrical façade, hall-and-parlor interior plan, moderately pitched side-gabled roof sheathed in wood shingles, boxed eaves with a prominent cornice and frieze, multi-pane double-hung wooden sash windows, and wood lap siding. Two red brick chimneys project from the ridgeline. A full-width front porch extends across the façade, supported by evenly spaced square wooden posts with decorative brackets. The porch roof is an extension of the primary roof form. A large water tower, reportedly constructed between 1890 and 1940, is attached to the main house via a modern walkway addition built circa 2003 (City of Lacey 2012).

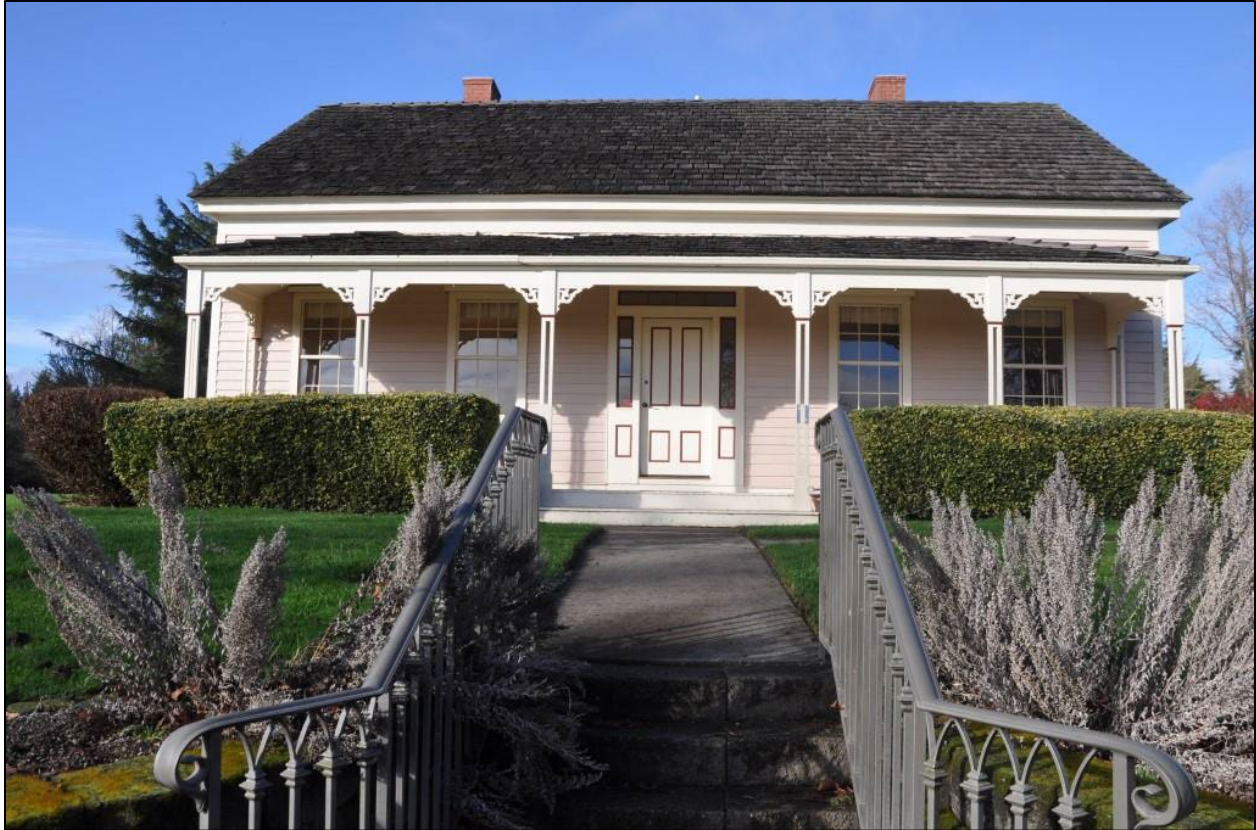
**Photo 5. View of main façade (south), taken in February 2025.**

The main elevation (southwest) features a centrally placed wooden pedestrian door with a four-panel design, flanked on each side by two symmetrically positioned double-hung windows with multi-pane upper sashes. The porch roof is hipped and clad in the same wood shingles. Decorative brackets connect the roof to the evenly spaced square wooden posts. The front steps leading up to the porch are concrete and are accessed via a symmetrical walkway with metal railings (Photo 5).

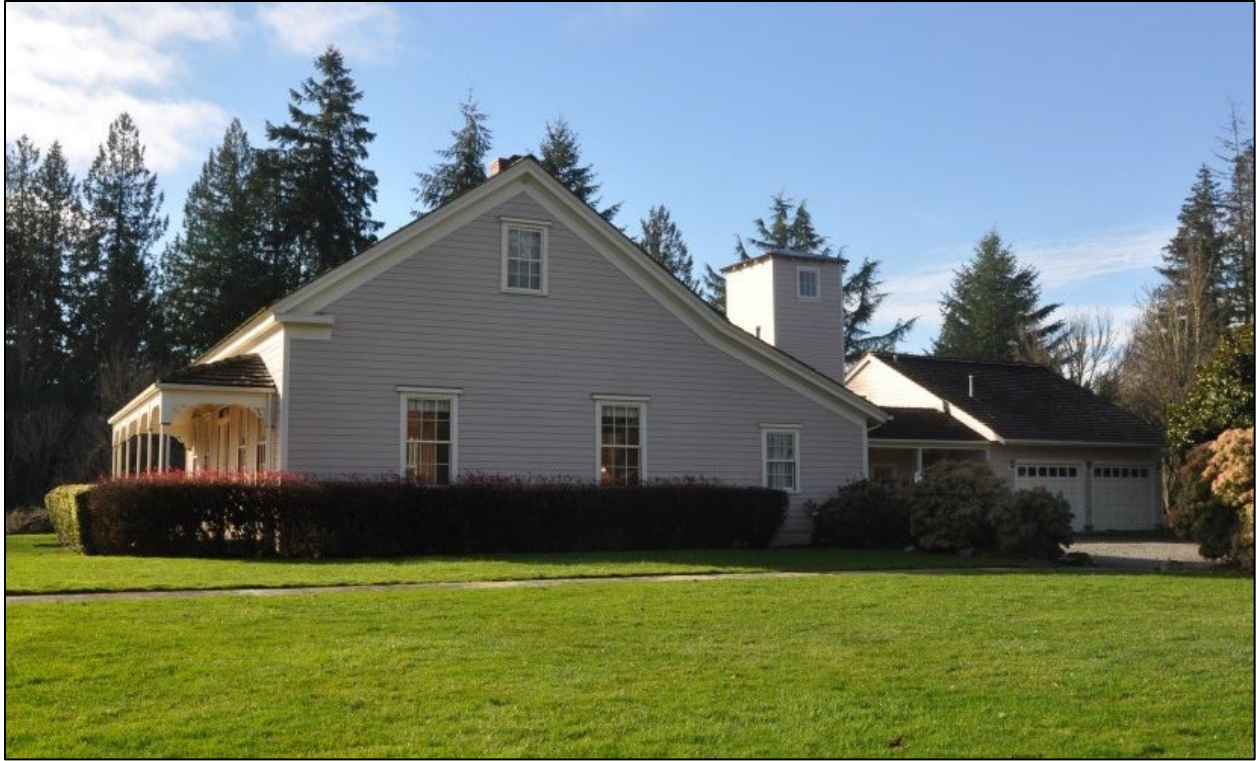
**Photo 6. View of the east façade with water tower and detached garage. Taken February 2025.**

The west façade contains a prominent small bay window capped with a hipped roof, near the center of the elevation. It features three large fixed-pane windows with a decorative scalloped valance along the upper sash of the central window. Two other wooden framed windows include a single-light lower sashes in its gable end and a double-hung sash windows on its south corner near the main porch. The east elevation contains a single multi-pane attic window centered in the gable end, and two evenly spaced, double-hung sash windows with multi-pane upper sashes and single-light lower sashes (Photos 6 and 7).

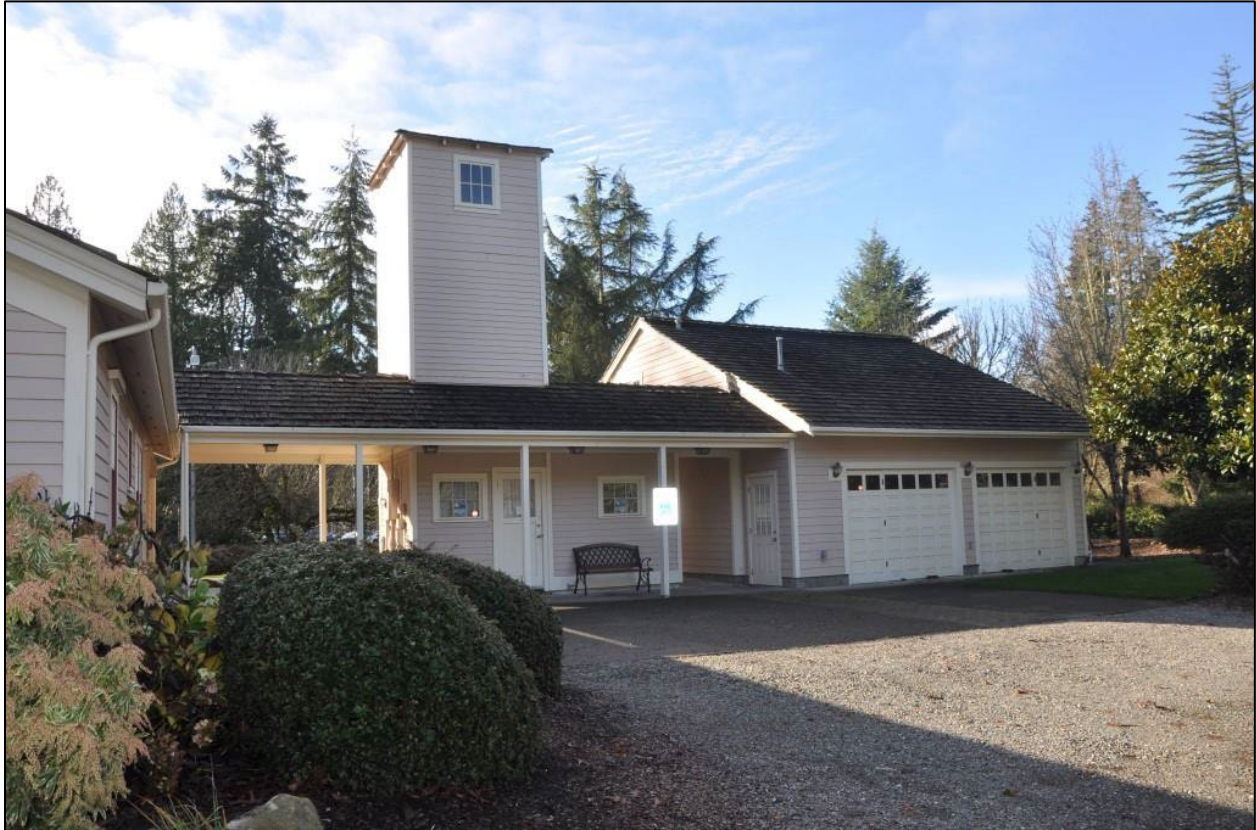
**Photo 8. Water tower and detached garage apartment with breezeway, taken in 2025.**

The rear (northwest) elevation includes a covered walkway connecting the main dwelling to the water tower and detached garage. A prominent, square, tower-like addition rises from the rear, clad in the same horizontal wood siding and featuring a shed roof with a louvered vent at the peak. The attached two-story rear addition has a gabled roof and modern vinyl windows. A covered breezeway, supported by square wooden posts, connects the garage to the main dwelling. This passageway has a shed-style roof that extends from the main garage volume, maintaining visual continuity with the primary structure. The breezeway includes a secondary entrance with a single-pane glass door (Photo 8).

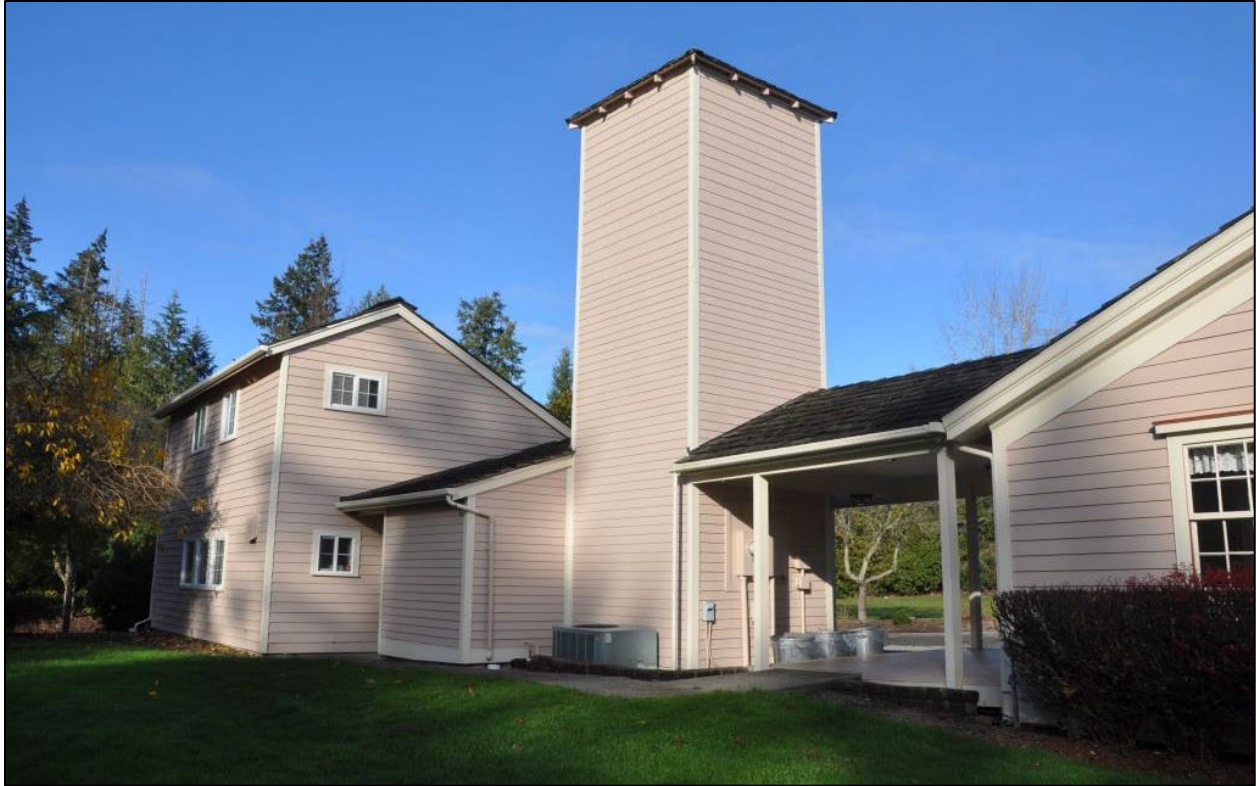
**Photo 9. View of modified garage-apartment and breezeway, taken in 2025.**

The attached garage apartment addition is a two-story structure extending from the rear of the primary dwelling. The garage portion is a single-story volume clad in the same horizontal wood lap siding as the main house. Two metal garage doors are symmetrically placed on its east façade. The apartment portion is a two-story, gable-roofed volume, with fenestration consisting of vinyl single- and double-hung windows. The rear elevation of the apartment features an additional entrance and a series of modern vinyl windows (Photos 9 and 10).

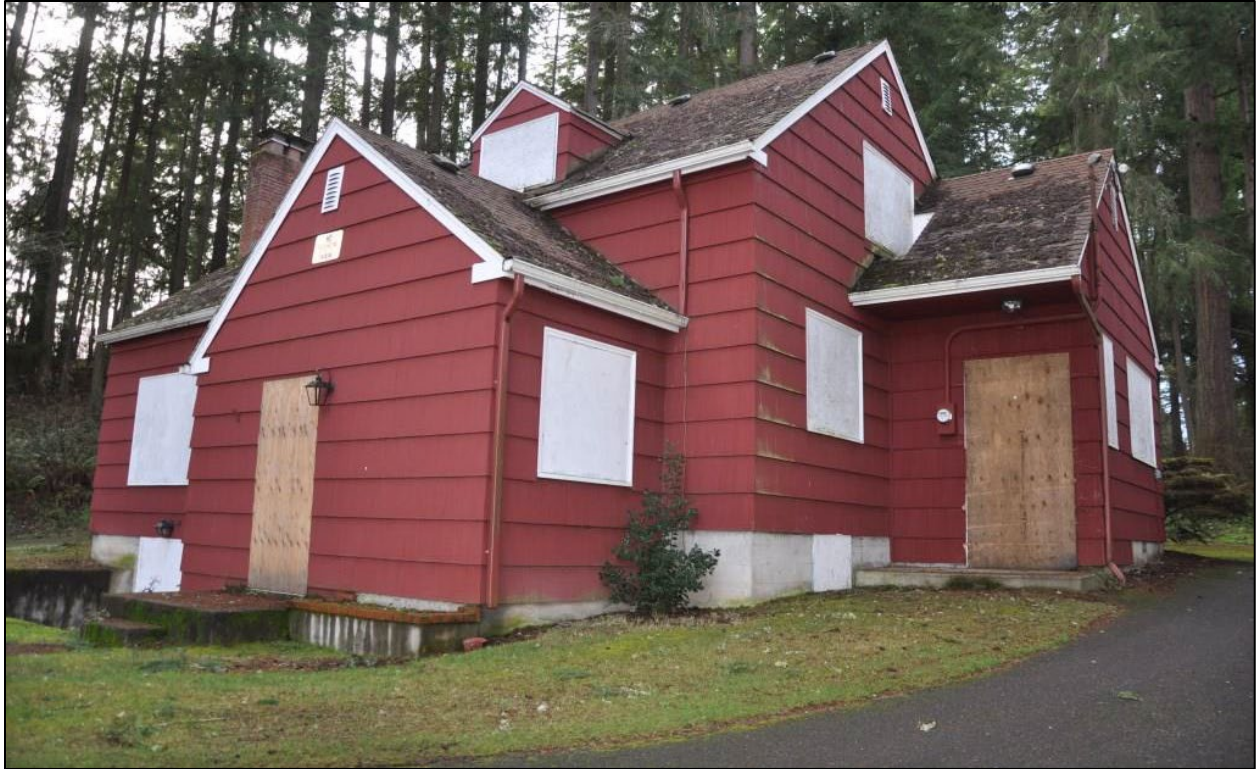
**Photo 11. View of main façade (east) and north façade, taken in 2025.**

The house features a side-gabled roof with asphalt shingles, wood shingle siding, two front-facing gabled dormers, and an exterior red brick chimney on the west elevation. The exterior is clad in horizontal wood shingles painted red with white trim accents. The structure sits on a poured concrete foundation with a partially-exposed basement, accessed via a recessed doorway on the north elevation (Photo 11).

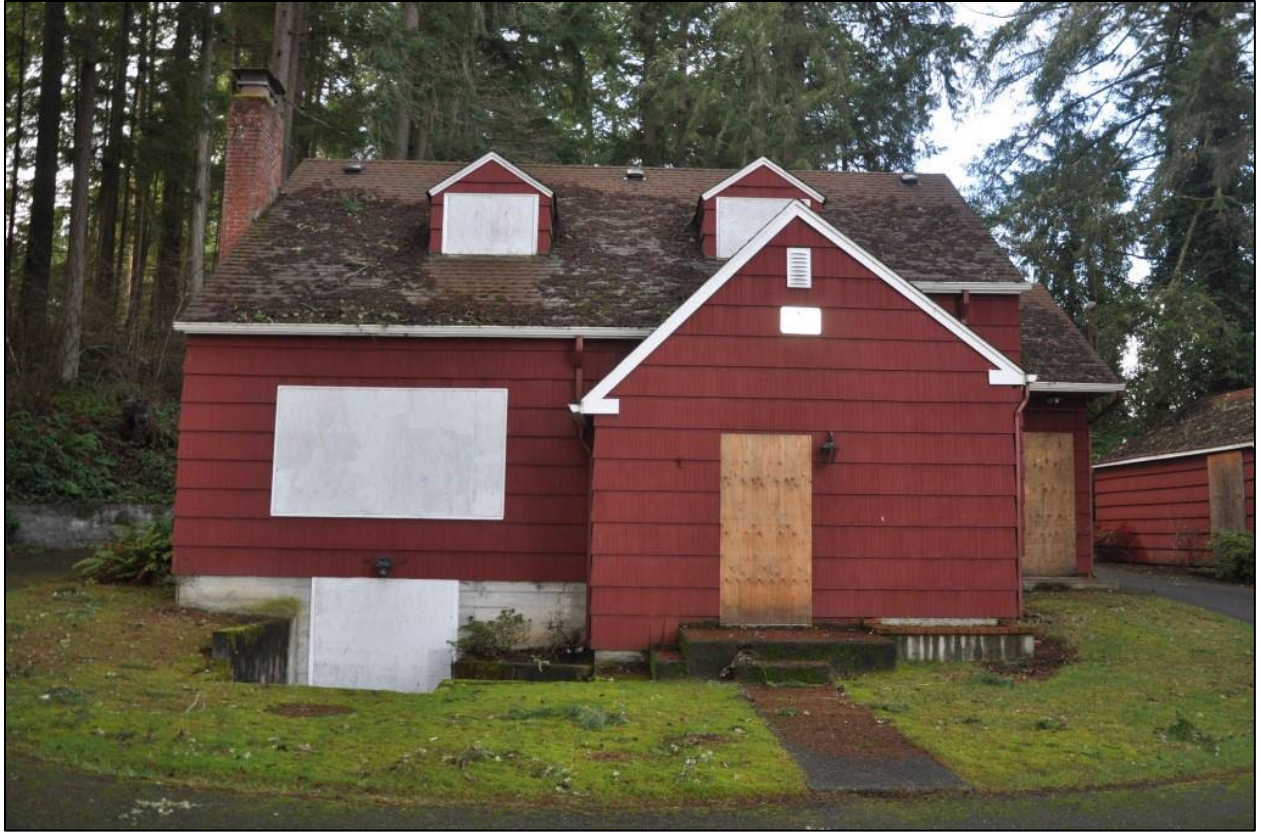
**Photo 12. View of main (east) façade, note infill of windows and doors. Taken in 2025.**

The primary façade (east) contains the main entrance—a single wooden door within a projecting entry wing, now boarded over—accessed by a small concrete stoop with two concrete steps. A secondary basement entrance is located partially below ground, adjacent to the main entrance on the east elevation; it is also boarded over. Fenestration includes multiple boarded-over windows that likely contained fixed panes in the two gable dormers. A large picture window, located to the left of the entrance, is similarly boarded over. A large, full-stack brick chimney dominates the south façade. Two boarded-over window openings on this elevation may have originally contained double-hung sash windows (Photos 12 and 13).

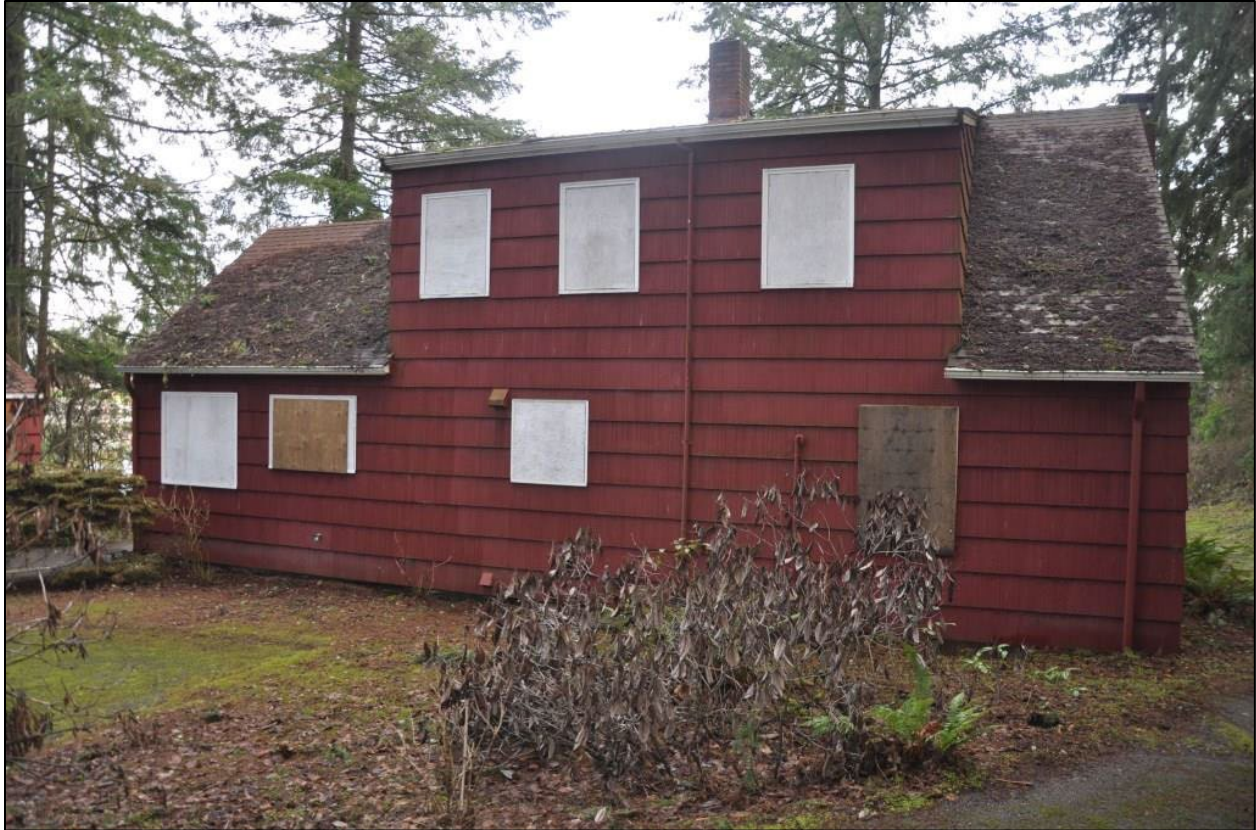
**Photo 14. View of rear (west) façade, taken in 2025.**

The west (rear) elevation features the two-story main massing and the single-story wing (north). The portion of the house on the left side of this elevation, contains two boarded-over window openings. A single chimney, constructed of red brick, protrudes from the roof ridge near the center of the structure. The two-story section has a shed roof which projects from the original gable roofline. This section contains three evenly spaced window openings on the upper level and two on the lower level, all of which are boarded up.

The original section of the house, on the left side of the elevation, features a steeply pitched gable roof with minimal eave overhangs. A small attic vent is positioned within the gable end. Three window openings on this portion are covered with plywood, obscuring their original configuration. Moss and organic debris are visible along the roof surface, particularly along the lower edges (Photo 14).

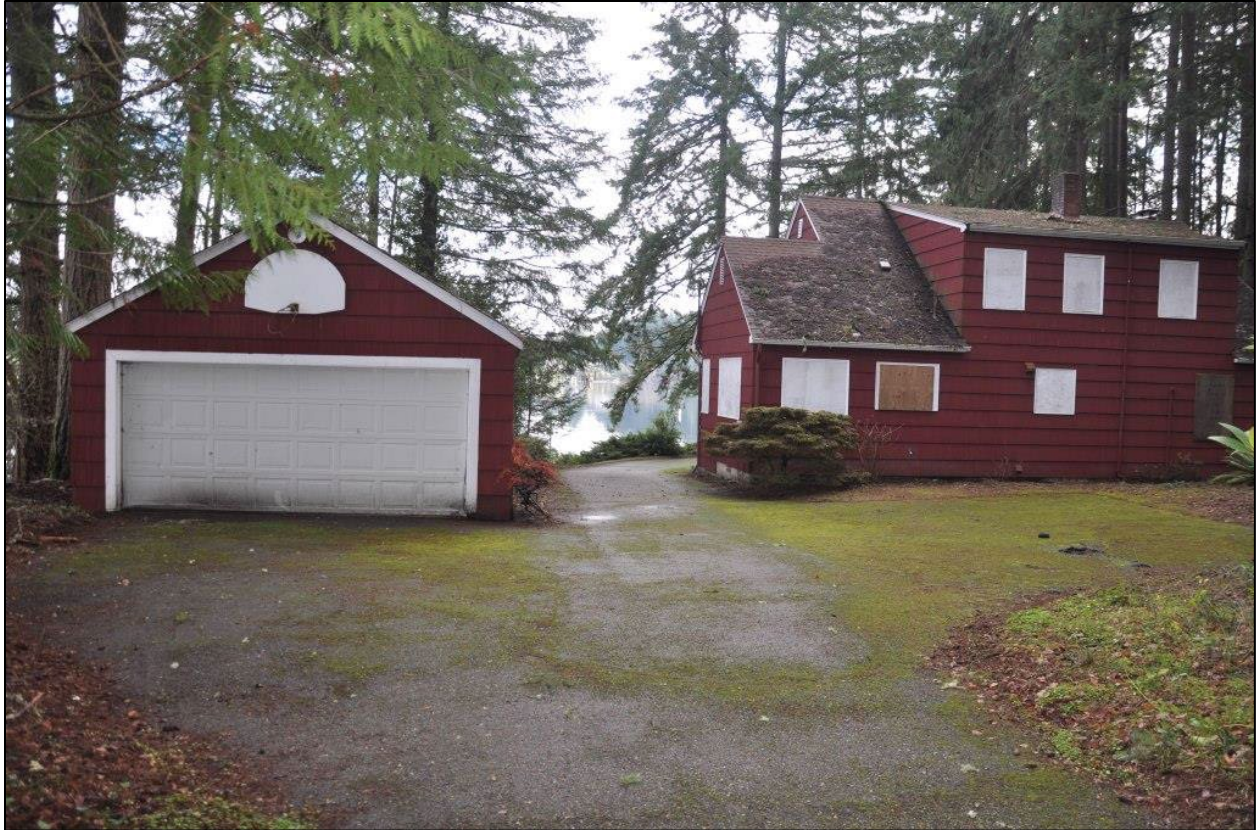
**Photo 15. Detached garage on north side of the house, view from west, taken in 2025.**

The detached garage is located northwest of the main house. It is a single-story structure with a front-gabled roof clad in asphalt shingles. Its exterior mirrors the house, with red-painted wood shingles and white trim. A large modern metal vehicle garage door is the main entry. A pedestrian door and four windows on the east elevation are boarded over (Photo 15).

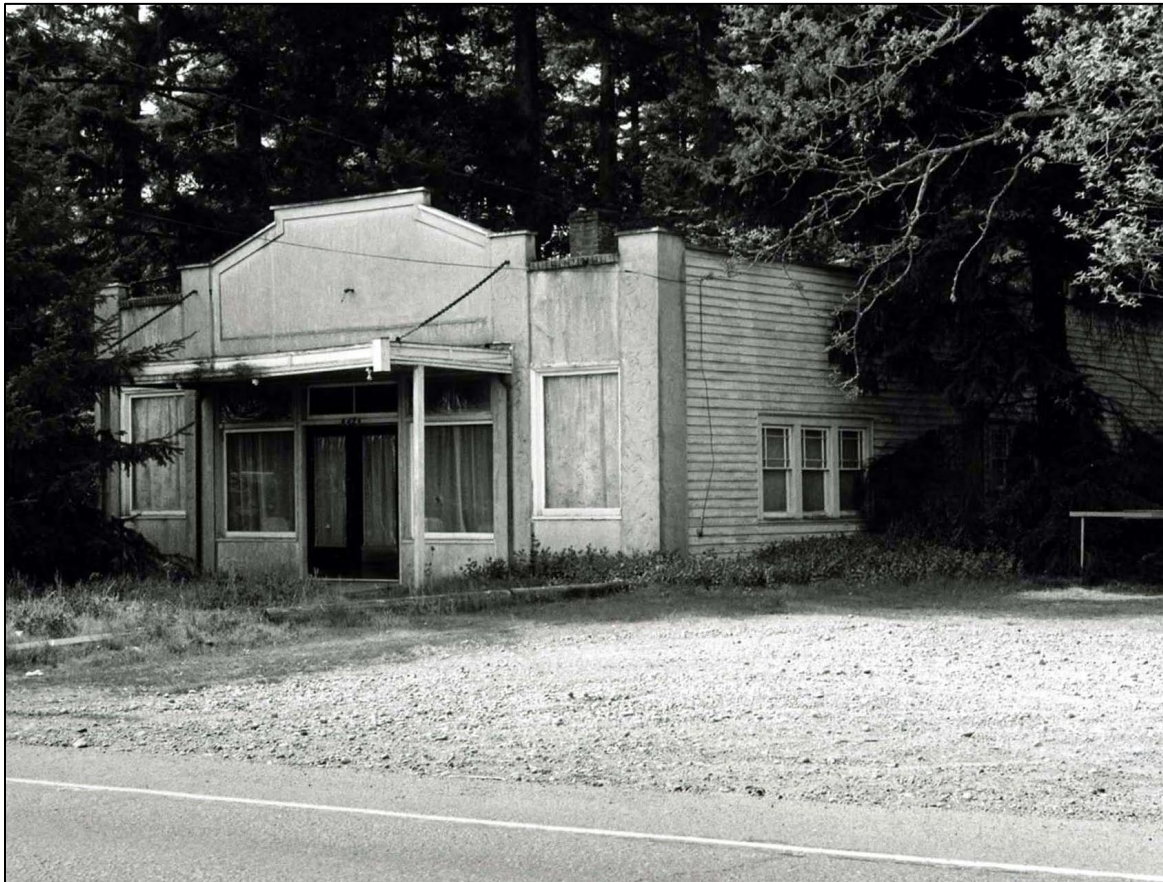
**Photo 16. View of main (south) façade and east façade, taken in 1987.**

Visual inspection of the property reports that the building is in a state of decay. In 2002, the building was recommended for demolition, but the Lacey Historical Commission sought to preserve the structure and as a result the City committed \$50,000 dollars to stabilize the structure. In 2013, students from Saint Martin's University created site plans "to assist in the planning and future development of the Lake Lois Park and Habitat Reserve" (Photo 16).

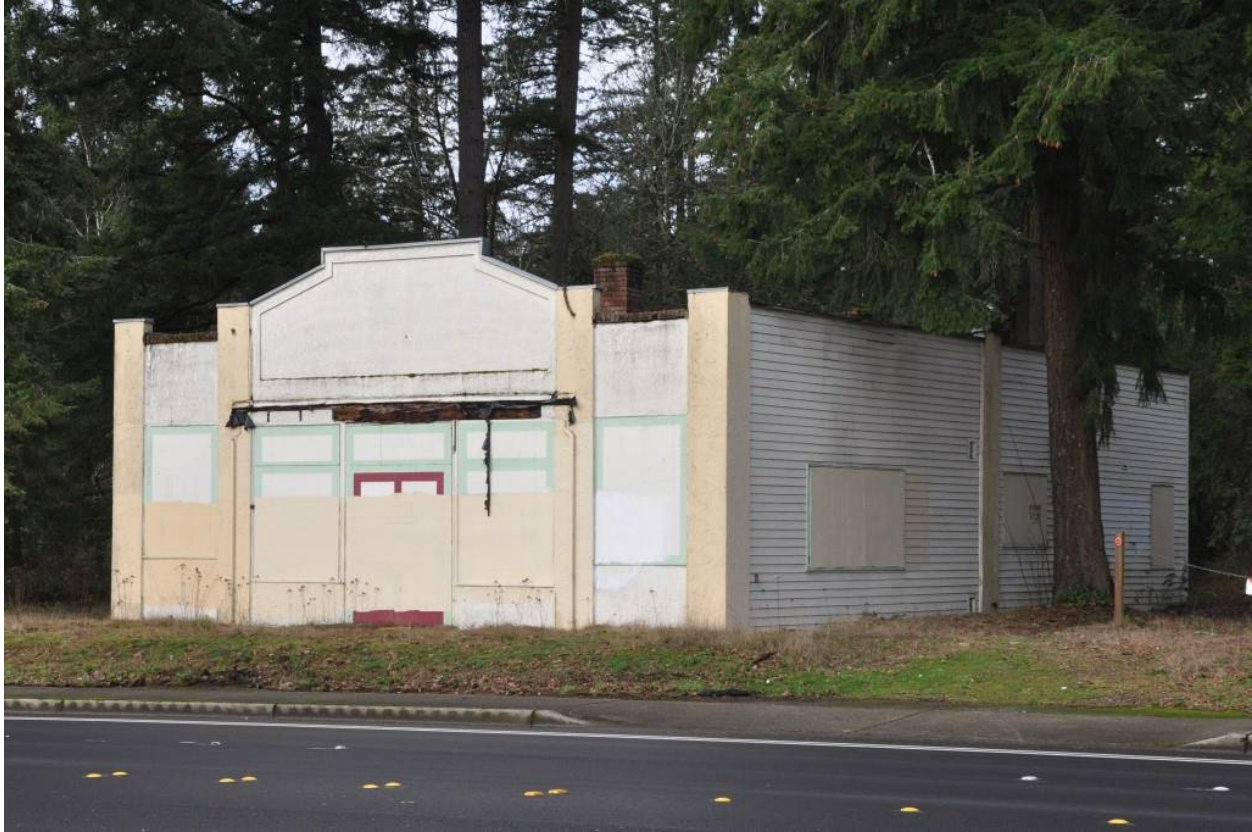
**Photo 17. Current condition (2025) of the McKinney House, boarded over windows and doors.**

Since that time, the structure's roof has deteriorated and is now at risk of collapse. The building is currently shuttered and structurally unsound. Modifications to its exterior design, material

degradation, and the loss of original fenestration elements have significantly diminished its integrity of materials, workmanship, and feeling.

The primary (south) façade features a prominent stepped false-front parapet with stucco-finished columns and plywood siding. Its main entrance—a set of double-leaf doors—has been boarded over to prevent vandalism. The doors are flanked by large window openings, which are also infilled. The remains of a porch awning are located directly above the doors and narrow windows, all of which are now boarded (Photo 17).

- **Structural Deterioration and Safety Concerns**  
The building is in poor condition and continues to deteriorate. Planning for demolition now is preferable to waiting until the structure becomes precarious or requires emergency demolition.

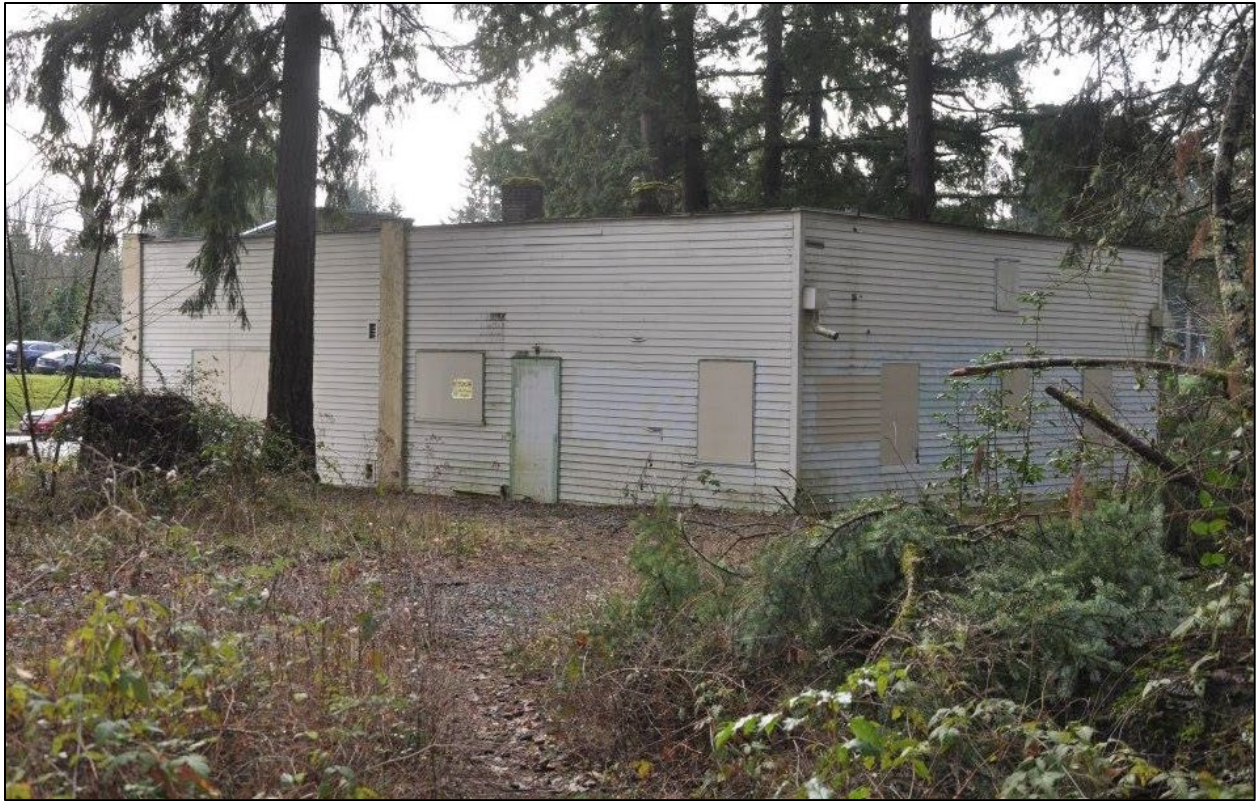
**Photo 18. View of east façade and rear (north) façade, taken in 2025.**

The east and west elevations are clad in horizontal wood siding, now weathered and marked by graffiti and staining. The east elevation includes multiple boarded-over window openings and a secondary door, which is also boarded. The west elevation features additional window openings, now covered, and an exterior electrical fixture mounted near the upper wall. A stucco column centered on each façade visually divides the building between the commercial and residential sections. The rear (north) elevation continues the horizontal wood siding and features a simple, flat-roofed profile. All window openings on this elevation are infilled with plywood (Photos 18–20).

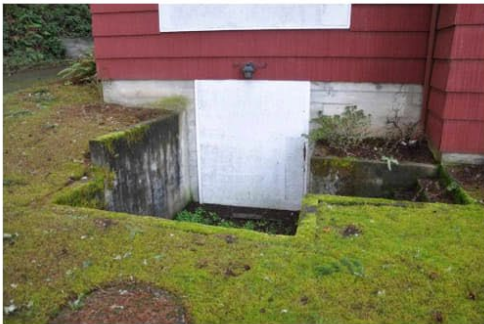
035 CloseUp of basement access.jpg

The house features a side-gabled roof with asphalt shingles, wood shingle siding, two front-facing gabled dormers, and an exterior red brick chimney on the west elevation. The exterior is clad in horizontal wood shingles painted red with white trim. The structure sits on a poured concrete foundation with a partially exposed basement, accessed via a recessed doorway on the north elevation.

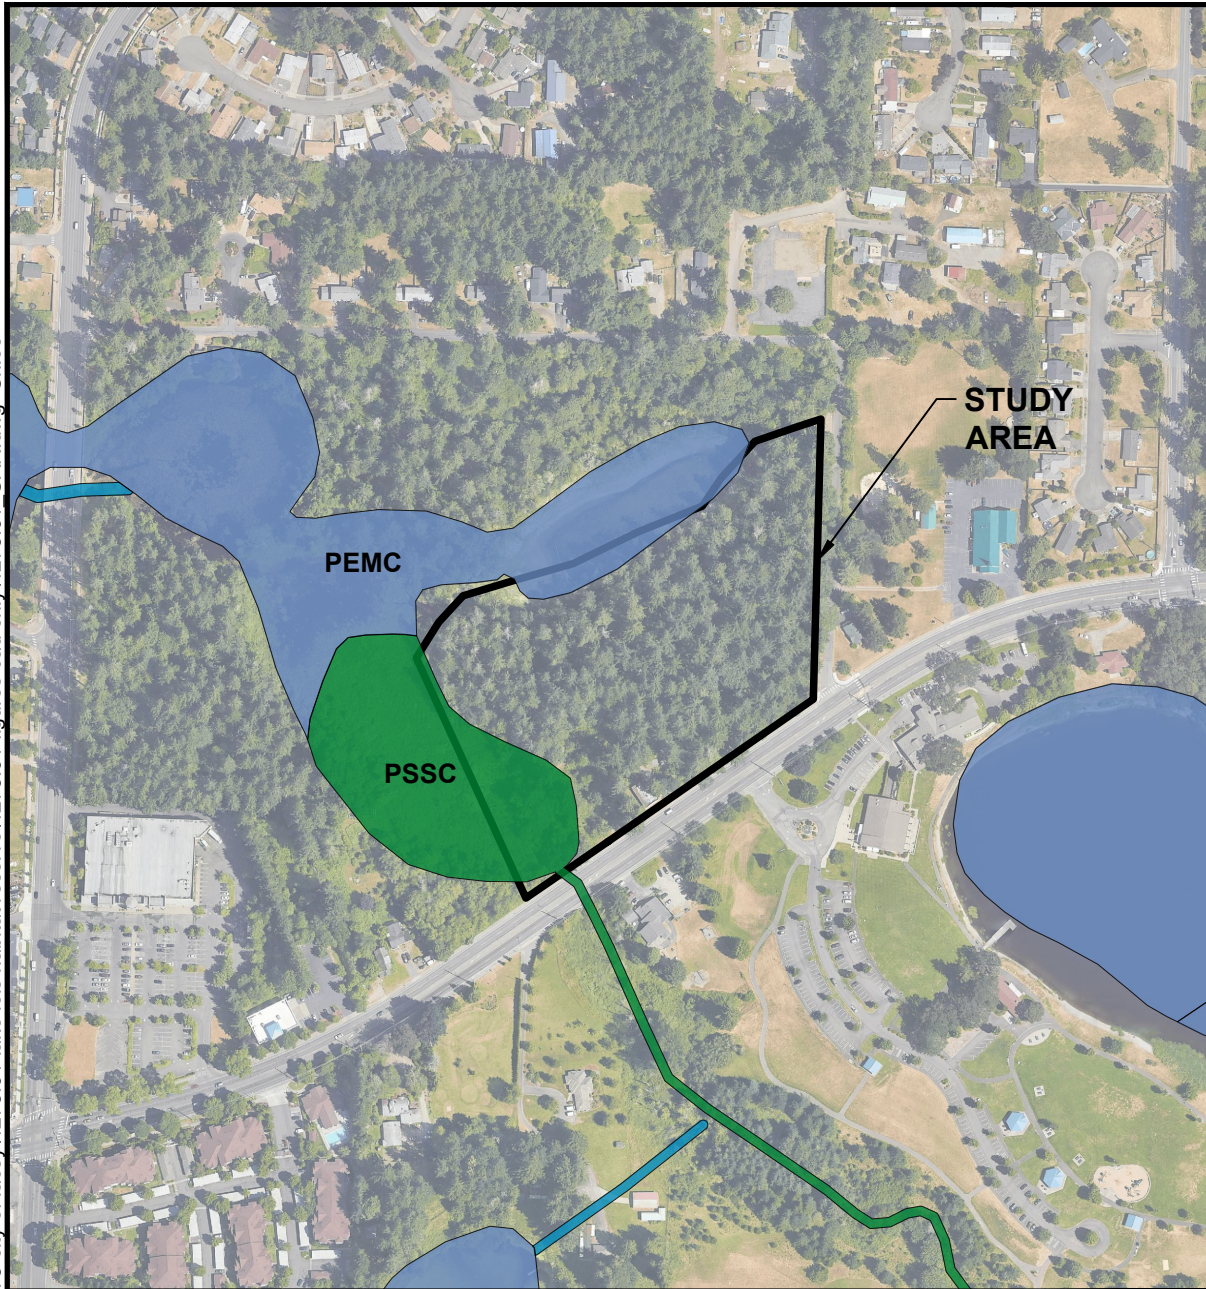
Figure 3  
NRCS SOIL SURVEY  
Lake Lois Habitat Reserve  
City of Lacey  
City of Lacey, Thurston County, Washington  
Section 14, Township 18N, Range 01W, W.M.

The Natural Resources Conservation Service (NRCS) maps the soils within the study area as (NRCS 2024A; Figure 3):

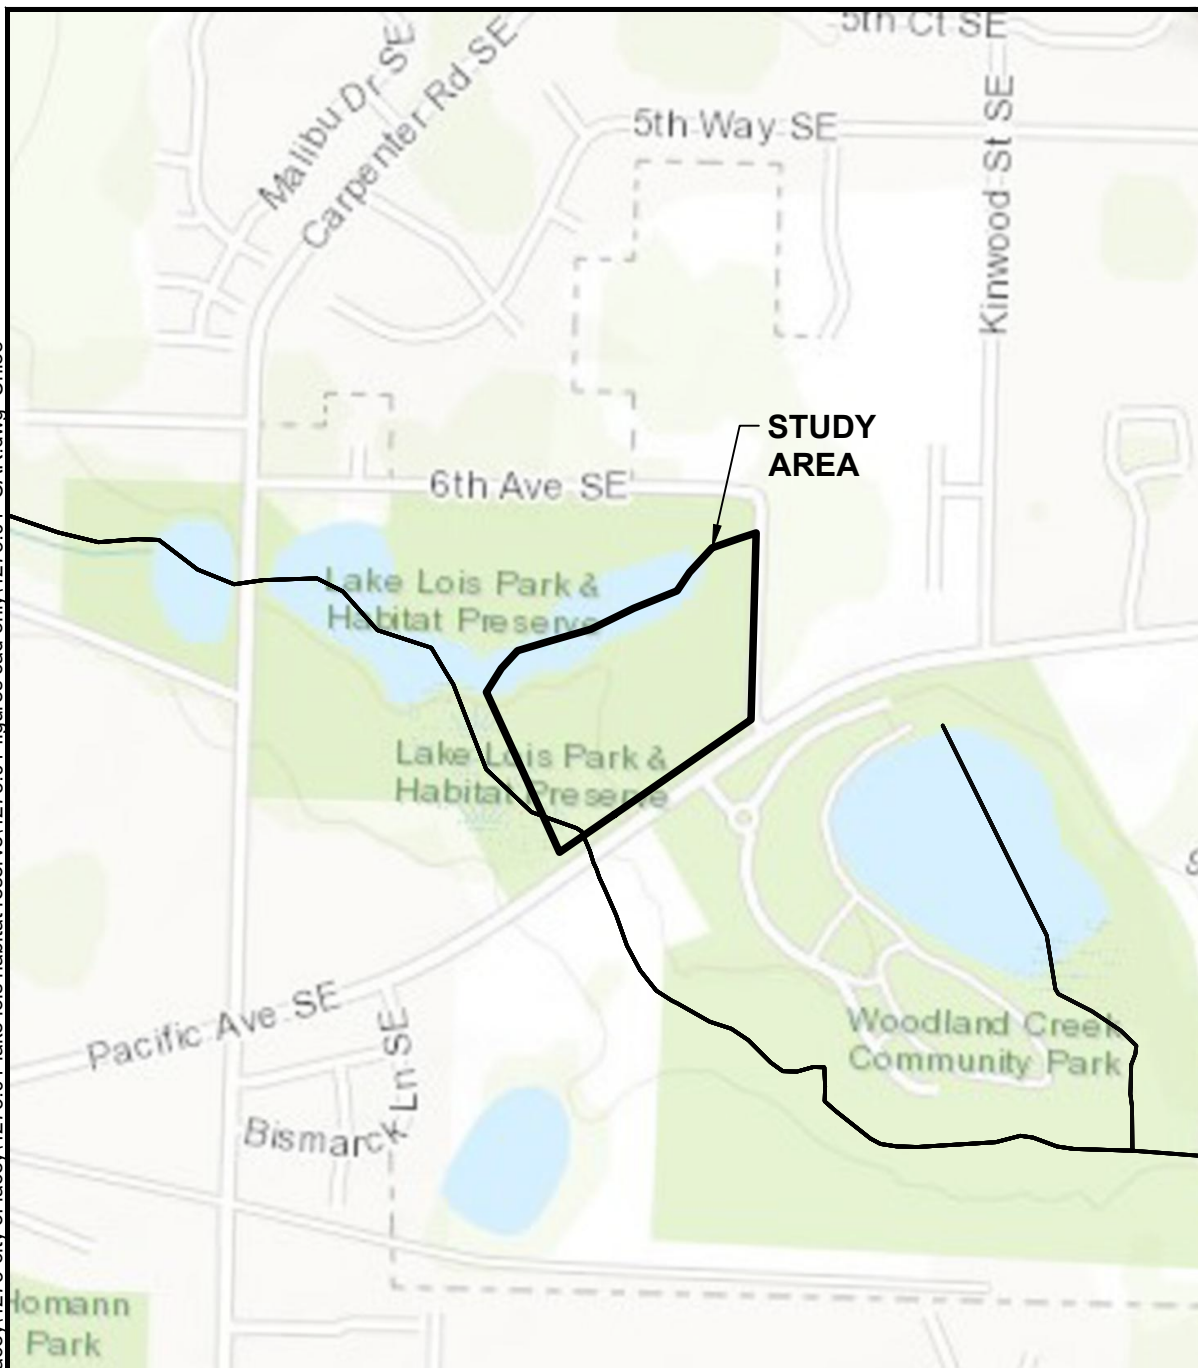
Figure 7  
WDNR STREAM TYPE MAP  
Lake Lois Habitat Reserve  
City of Lacey  
City of Lacey, Thurston County, Washington  
Section 14, Township 18N, Range 01W, W.M.

The WDNR Stream Type Map (WDNR 2024) maps Lake Lois as x (non-typed) and fish bearing and indicates the presence of a Type F stream approximately in the same location as the other databases (Figure 5). ELS biologists generally agree with the WDNR map because Lake Lois and Woodland Creek are shown in approximately the same location.

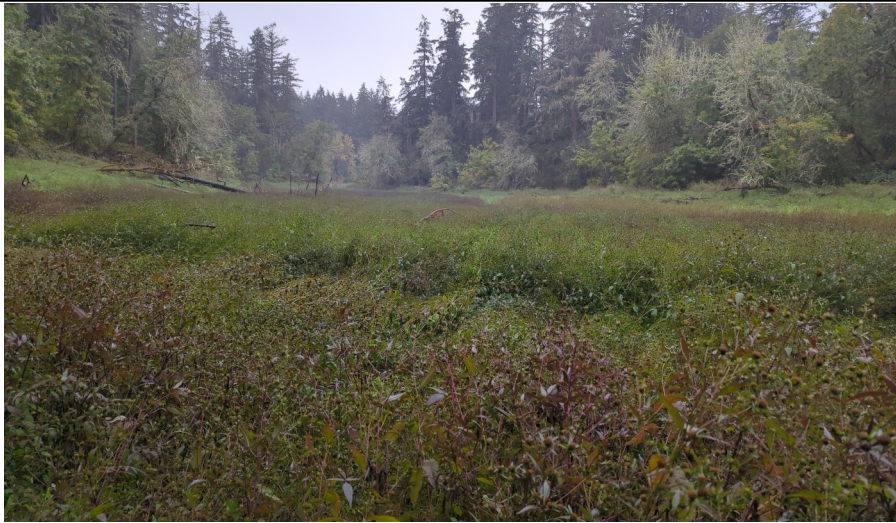
**Photo 1.** Facing offsite to the west from Test Plot 1 showing the dense, emergent vegetation within Lake Lois. This portion of the wetland is seasonally inundated and does not contain hydrology during this time of the year. October 2024.

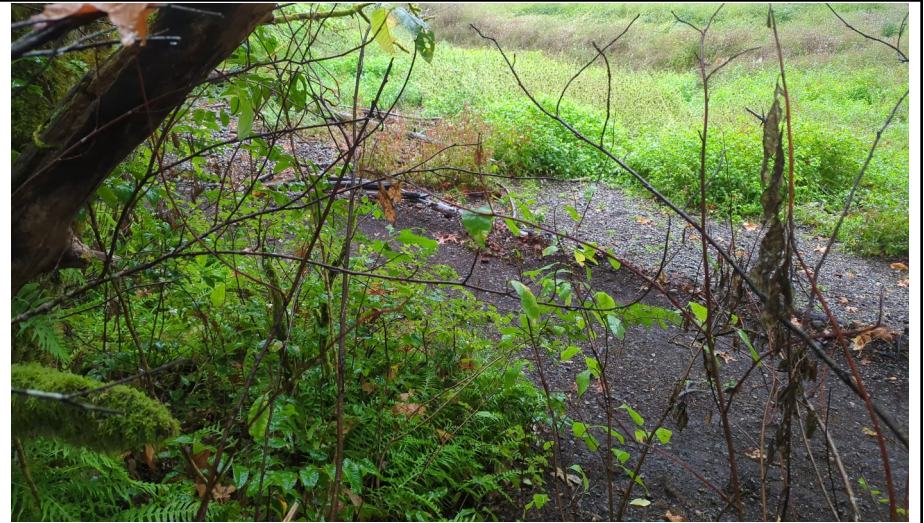
**Photo 2.** Facing west from Test Plot 2 showing the upland vegetation and walking path adjacent to Lake Lois. October 2024.

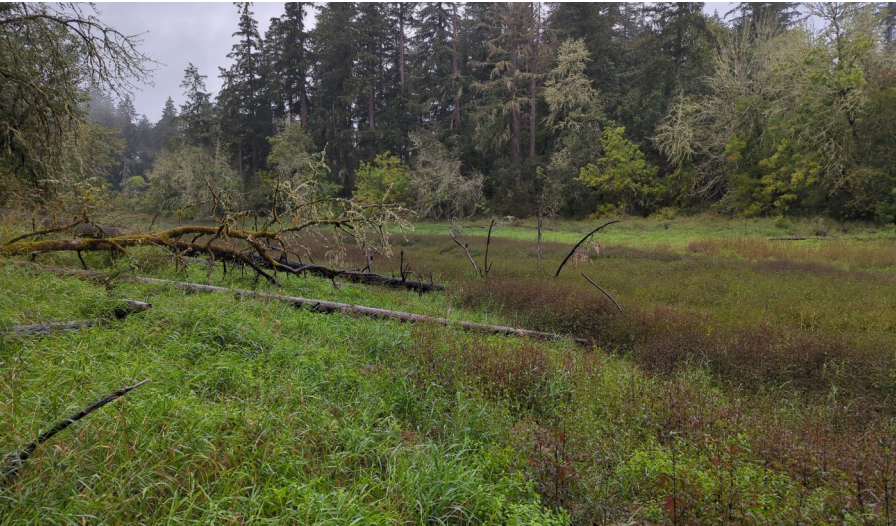
**Photo 3.** Facing northwest from the south boundary of Lake Lois in the north-central portion of the study area. This photo shows the change in topography within the wetland, and also the downed woody debris. October 2024.

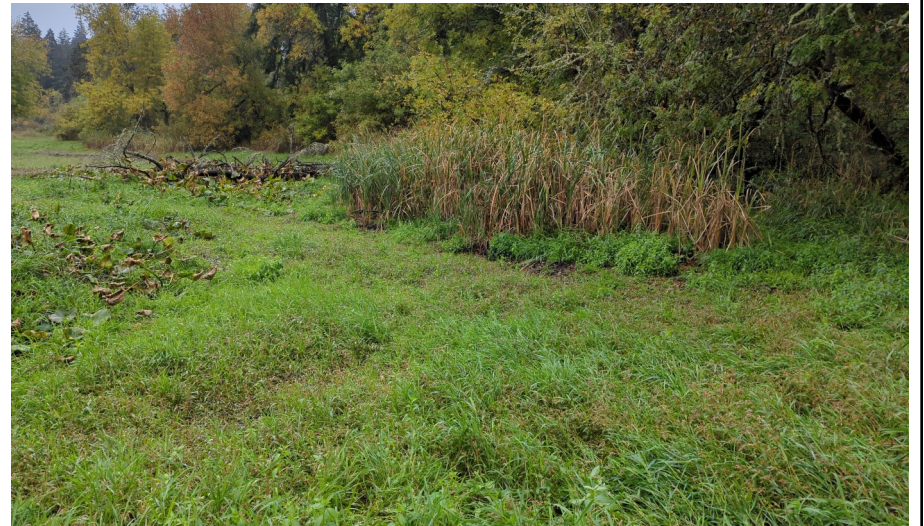
**Photo 4.** Facing north from Test Plot 3 showing the difference in emergent species within Lake Lois. This portion of the wetland is seasonally inundated and does not contain hydrology during this time of the year. October 2024.

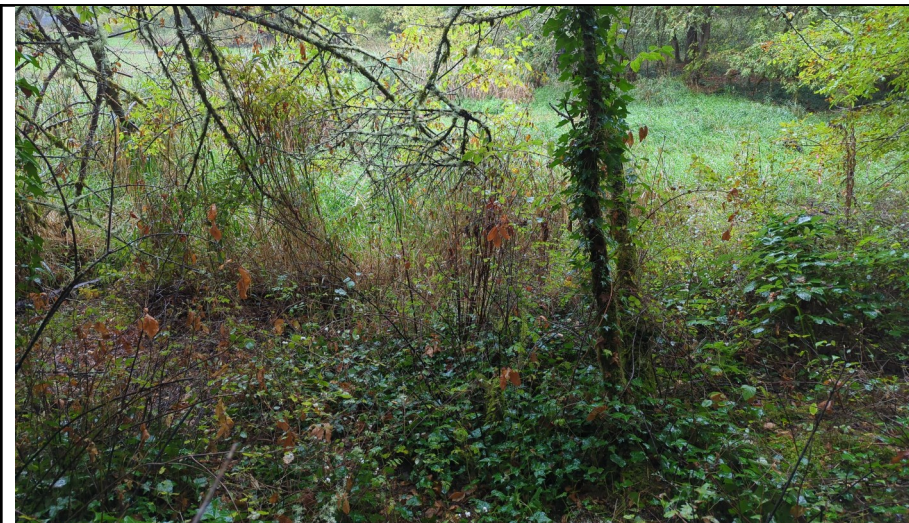
**Photo 5.** Facing west from Test Plot 4 showing the upland vegetation adjacent to Lake Lois. There was a large percentage of English ivy within the wetland buffer. October 2024.

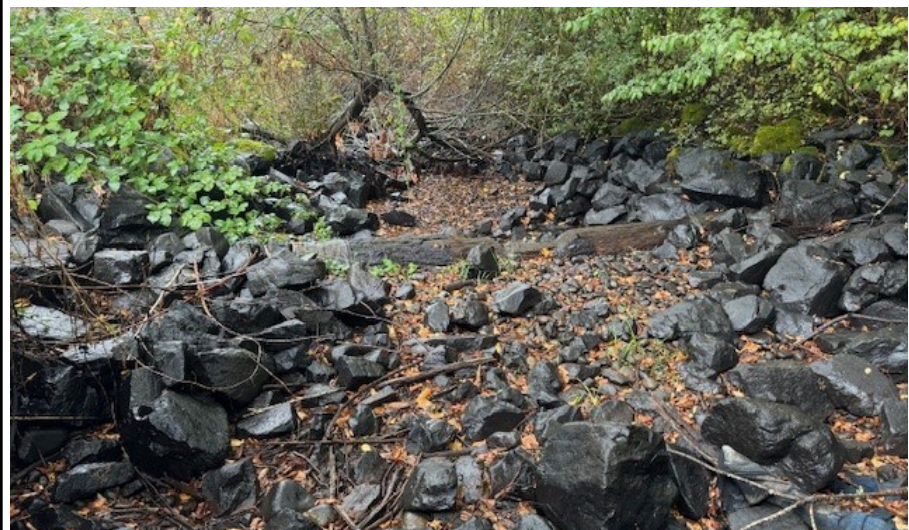
**Photo 7.** Facing northwest from the channel of Woodland Creek in the southernmost portion of the study area. The boundary of Lake Lois is just beyond the large cobbles and brush. October 2024.
