## Lacey City Council Worksession Agenda

**B. McKinney Building Removal**

**Historic Preservation Consultant Services for Three Historic Properties, Lacey,  
Thurston County, Washington**

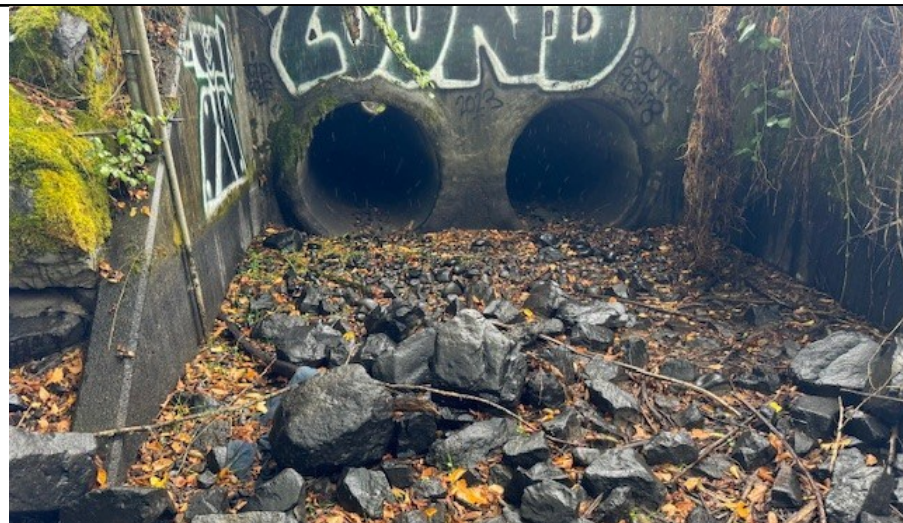
**Photo 6.** Facing southeast from the channel of Woodland Creek in the southernmost portion of the study area. The culverts are four feet in diameter and they span Pacific Avenue SE. October 2024.

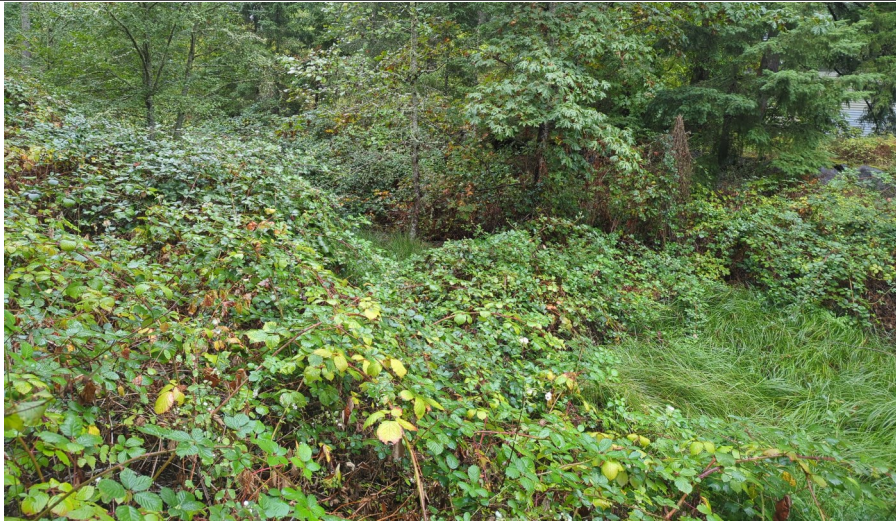
**Photo 9.** Facing north from the west side of the vegetated storm pond. The storm-pond is vegetated with a *Carex* species and Himalayan blackberry. October 2024.

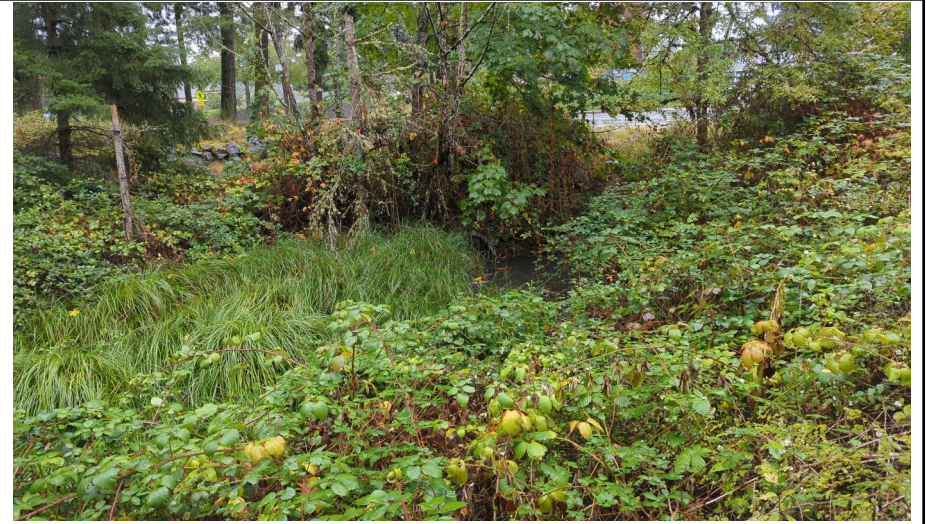
**Photo 10.** Facing south from the west side of the vegetated storm pond. The outlet culvert is shown in the center of the photo, on the south end of the pond. It is not known where the culvert leads to. October 2024.
